SUBJECT: Site Inspection, United Stone and Design, United Stone #1, S/047/074, Uintah County, Utah

S/047/074, United Stone and Design #1, United Stone and Design
Inspection Dated: May 20 and July 8, 2004; Report Dated: July 26, 2004

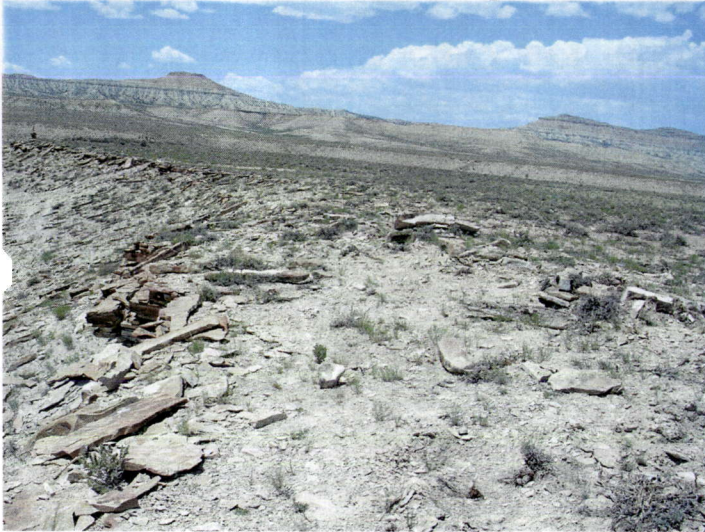
The lease with SITLA and the Notice of Intention with the Division allowed operations in the E½ of Section 36, Township 12 South, Range 20 East, SLBM. The disturbances I found in the E½ of Section 36 all appeared to be from hand gathering (Photos 1-3). There were some disturbances outside Section 36 that were probably done using mechanized equipment (Photo 4), and although this type of disturbance needs to be permitted with the Division, I do not know who did this work. These disturbances were small enough that they should heal quickly on their own as long as the areas are not redisturbed.

Photo 1. Some of the various small disturbances in the area.

This site can be released. The disturbances are small enough that they should heal quickly.

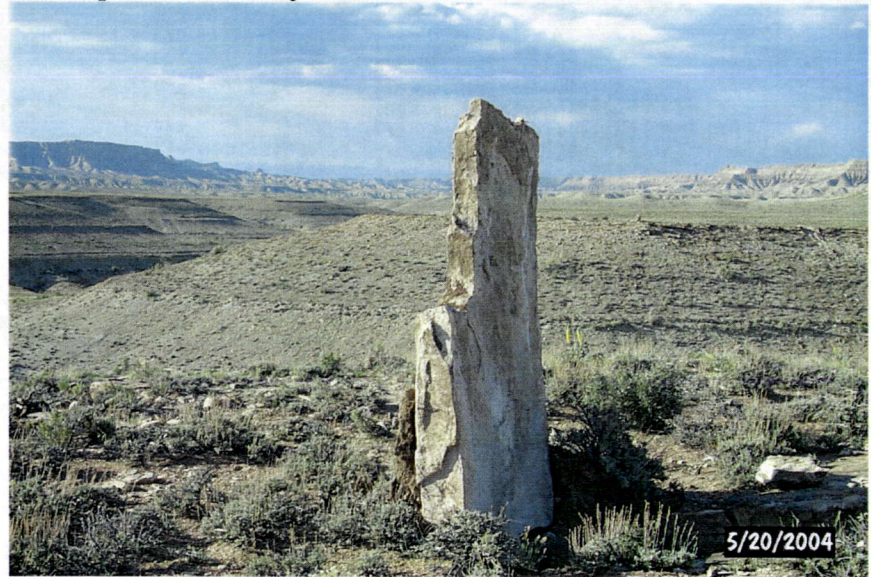
Photo 3. This rock is just south of Section 36, and I believe it is too large to be lifted by hand.
